Restoring the Great Clock of Westminster

By Chris McKay, BSc CEng MIEE MBHI

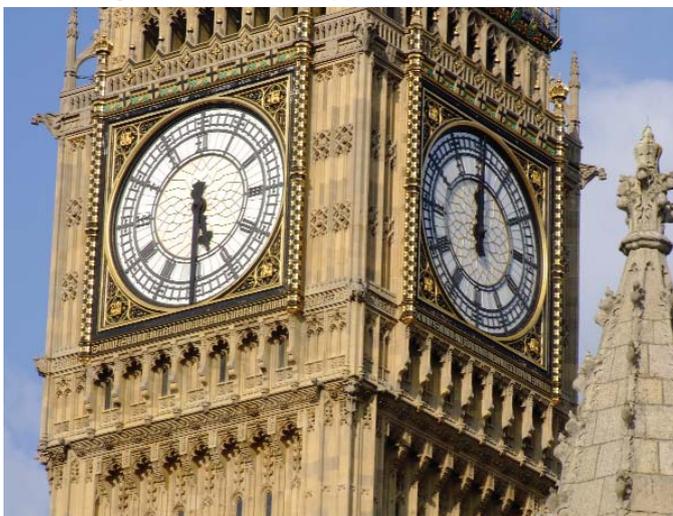
18. Two different times: A rarely-seen sight as one of the dials is being serviced.

Dials were taken out of action one at a time and set to 12.00. **Photo 18.** Motionworks were serviced with the anti-friction rollers that support the hour tubes. There are two sets of these, one pair inside the clock room next to the motion work **Photo 19** and a second set on an outrigger right behind the dial. In the past some of these rollers had seized up leading to flats on the surfaces of the rollers, so the opportunity was taken to repair these. Since the hour tube is about 12 feet above the floor in the dial chambers, a small scaffold tower **Photo 20** was used to get access to the various set of rollers. One of the shortcomings in the design of the Clock is support of the minute arbor. **Photo**

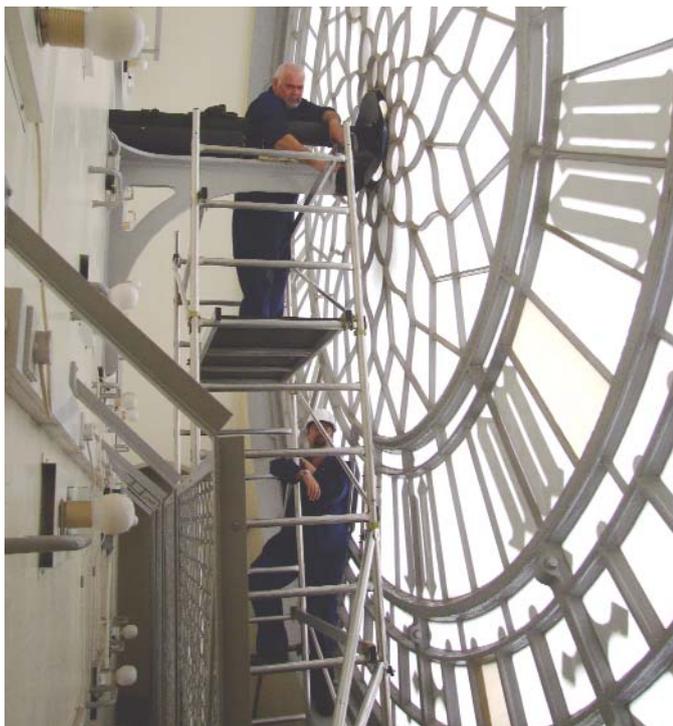
20. Scaffold behind dial to access the hour tube and minute arbor rollers.

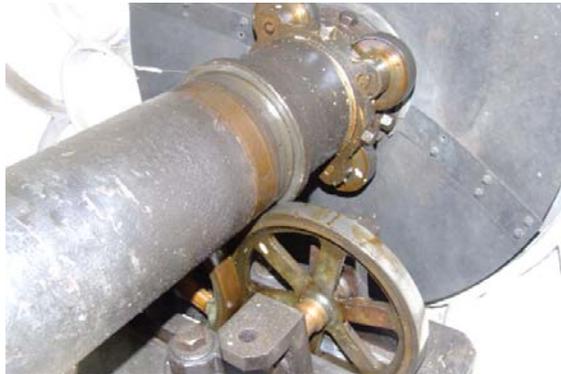
21. Normally on a turret clock this arbor just rotates inside a bush in the end of hour tube. At Westminster the hour tube has four slots cut out of the hour tube and the minute arbor is supported by four anti-friction rollers that are held by two cages bolted to the outside of the hour tube. Unfortunately the cages are complete rings that can only be removed when the hands have been taken off. Fortunately minimal work was needed on these bearings.

21. Friction rollers behind dial. The bottom pair of rollers take the weight of the hour tube, the cluster of four rollers mounted on the hour tube support the minute arbor.

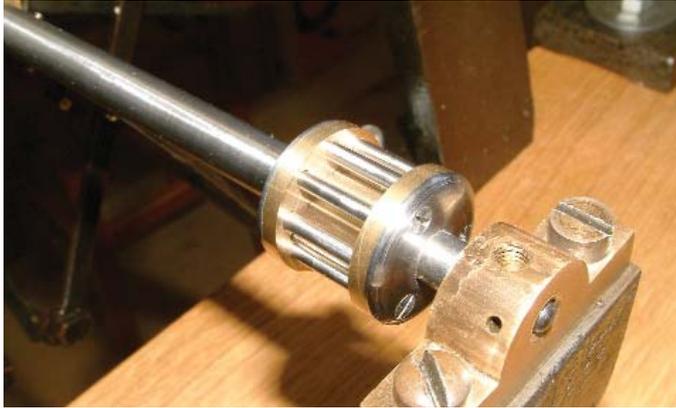
23. The finished lantern pinion and arbor made for the 'scape wheel.

As a complete opposite to the heavy work needed on the barrels and great wheels, the escapement was much more like conventional clock bench-work. Whilst the heavy work was going on at the engineering company the escapement was being rebuilt. A new lantern pinion, **Photos 22 & 23**, was made for the escapement and since its arbor had a whole series of holes, it was decided to make a new one. An examination of the escapement took place at Upton Hall, **Photo 24**, during the turret clock course held in September 2007. The gravity arms looked of a recent construction; there were several fixing holes showing the locking blocks had been moved or replaced at some time. Indeed the whole escapement did not have the look and feel of the rest of the clock suggesting it was a 20th century replacement. New blocks and lifting pins were fitted and flats on

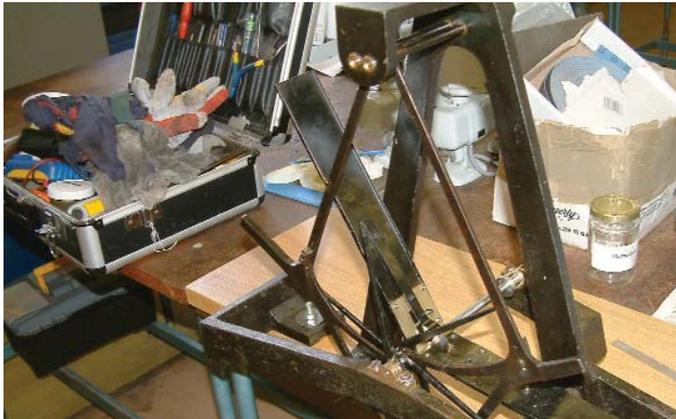
24. Edmund Beckett Denison's double three legged gravity escapement. The assembly was brought to Upton Hall for the turret clock course and inspection, discussion and advice was invited.

the gravity arms and the pendulum rod were all polished out.

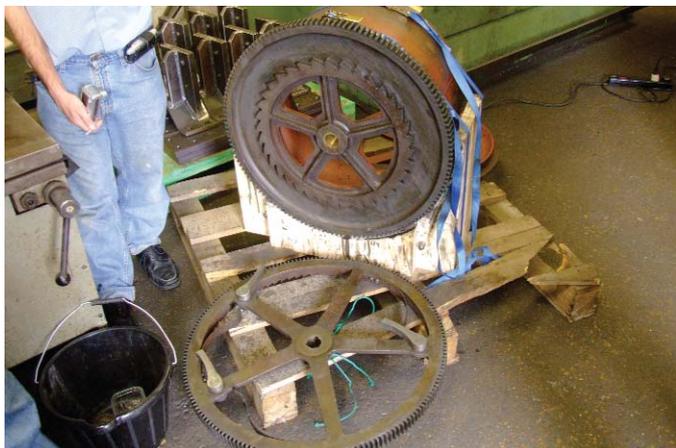
25. Going barrel and great wheel with its arbor removed. Note that three clicks are used, and the bronze bush in the barrel end.

On the going barrel, there are two end plates each with bronze bushes, **Photo 25**, and the arbor is fixed to the great wheel. In this case the arbor had three slots that corresponded with three slots on the great wheel and tapered wedges were hammered into the mating slots to secure the great wheel on its arbor. When it came to examine the great wheel, cracks were noticed, **Photo 26**, and a further examination was carried out with dye penetrants and magnetic techniques. The force of the wedges had caused the great wheel boss to crack, these cracks propagated from the sharp roots of the slots. Repairs were made using cold stitches, **Photo 27**, a technique commonly used in industry to repair cracked castings. Here a series of holes are drilled using a custom jig, the line of holes being at right angles to the direction of the crack. A specially-shaped lock insert is put into the hole and secured with a resin. The lock is made of a high-nickel steel alloy and is much stronger than the parent cast iron. Accurate drawings were made of the going great wheel, so in the unfortunate event of the wheel having to be replaced, the necessary information would be at hand. All the bushes were all repaired with new bronzes, but it was decided to make a new arbor, the great wheel being secured to the arbor with a single conventional Woodruff key, and the key retained with a collar.

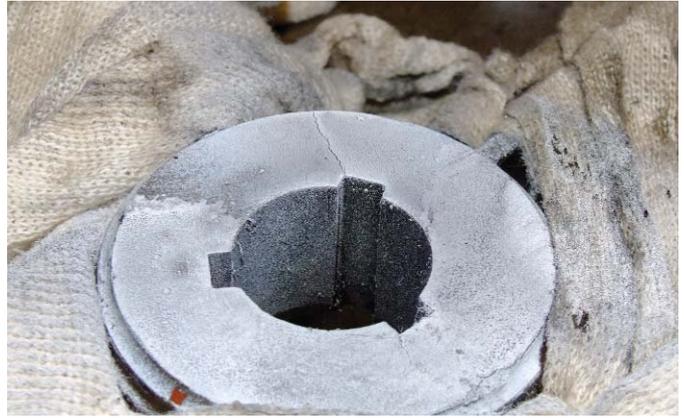
26. Cracks in going great wheel boss.

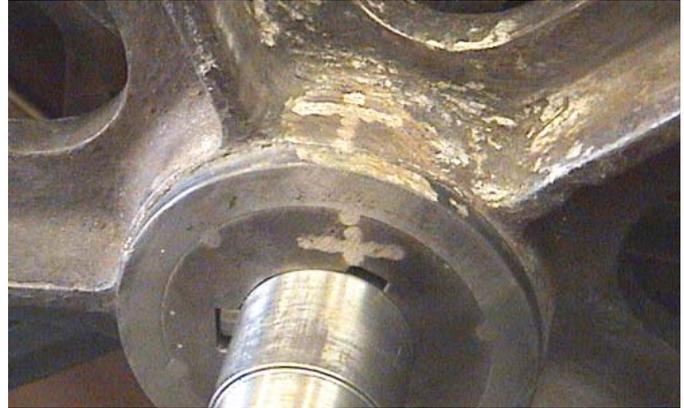
27. Repairs using cold stitches can be clearly seen looking like a row of filled holes.

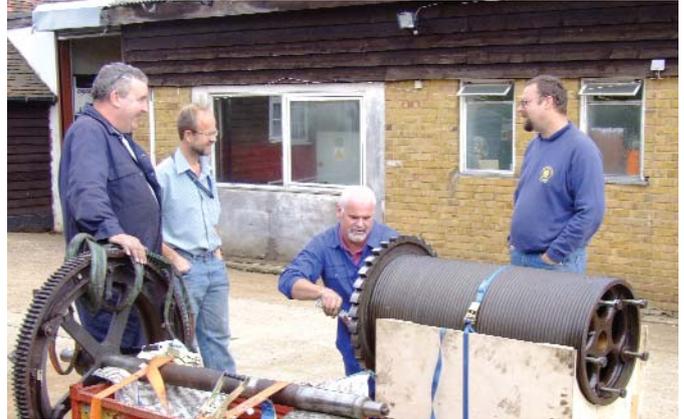
28. Striking barrel and great wheel at the engineering works.

The hour striking barrel, **Photo 28**, is a cast-iron hollow drum, **Photo 29**, with cast-iron endplates, one is the winding wheel **Photo 30**, and the other the ratchet wheel, **Photo 31**. Both of these have bronze bushes that were found to be worn. Also worn was a thrust washer that had allowed the ratchet wheel securing bolts to rub on the great wheel. First the main arbor was skimmed down, **Photo 32**, to remove wear. It was then decided to re-bush all the barrel bearings and to reline the split plumber blocks that act as the main bearings. One original bush had turned over time so the oil hole in the bush no longer lined up with the oil hole in the great wheel. New bushes were pinned to prevent this happening again. It looks like this was the first time in the clock's history that this bushing work has been needed; indeed it is a great tribute to its maker E J Dent. Clickwork and ratchet teeth were built up with weld and re-profiled where necessary.

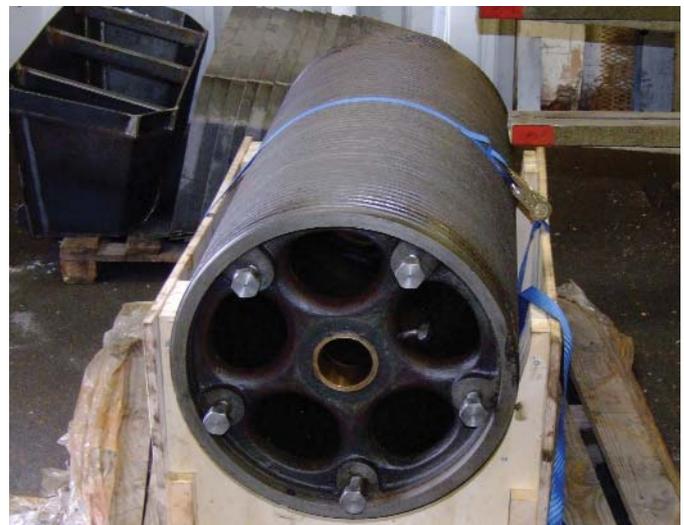
29. Barrel showing grooves to guide the line.

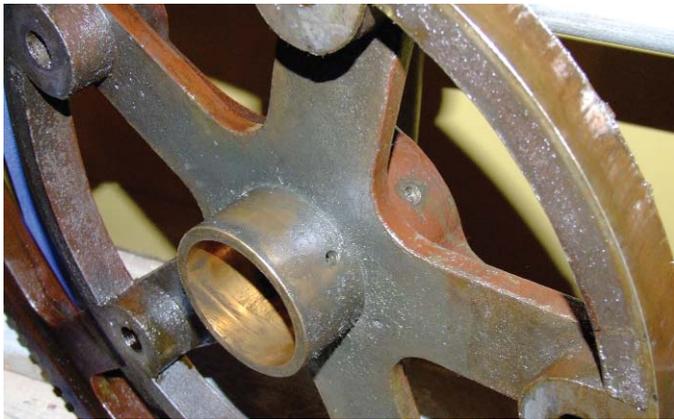
30. Bush in endplate of winding wheel. Note the oiling holes.

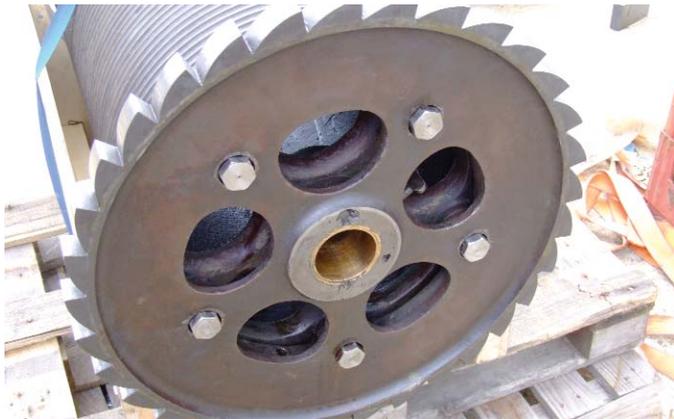
31. Ratchet wheel on hour striking barrel. At two o'clock the peg sealing an oiling hole can be seen.

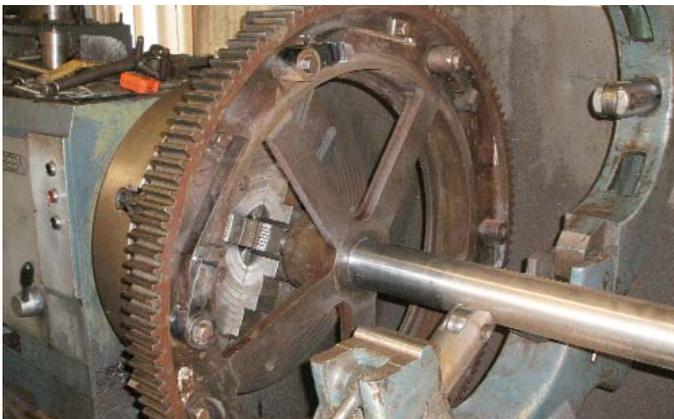
32. Great wheel on lathe 2.

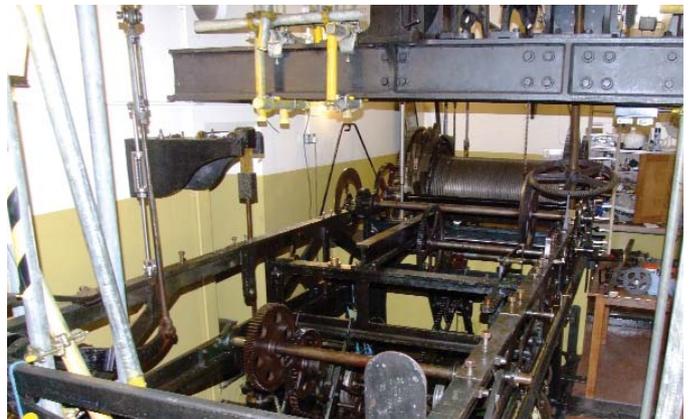
34. Empty clock frame.

With the flat bed frame empty, **Photo 34**, frame members and other parts were cleaned and all the necessary odd jobs completed. As the major parts came back from the engineering works they were hoisted up the tower and installed; the going train first, then the striking. First the going train was run without the gravity arms to identify any possible tight spots in the train. Speed of running was regulated by the fly on the reconstructed scape wheel. After several fault-free runs the gravity arms were installed and the clock set going. After a short series of adjustments the clock was brought to time and remained on test for a week before the official restarting.

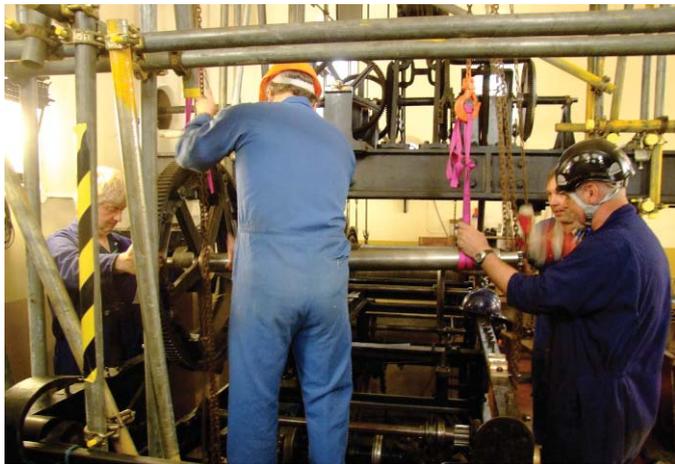
35. Great wheel and arbor being installed.

Once the strike barrel had been returned it was hoisted up the tower and the great wheel and arbor tested for true and smooth running in the frame. **Photo 35**. With all well, the huge barrel was installed **Photo 36** and again tested. Train and winding wheels were re-installed along with all the release and locking levers. The scaffolding was then struck and the striking fly and winding wheels re-instated. After a period of testing the Great Clock was deemed fit to resume normal duty.
