Hinton Martell Village Fountain

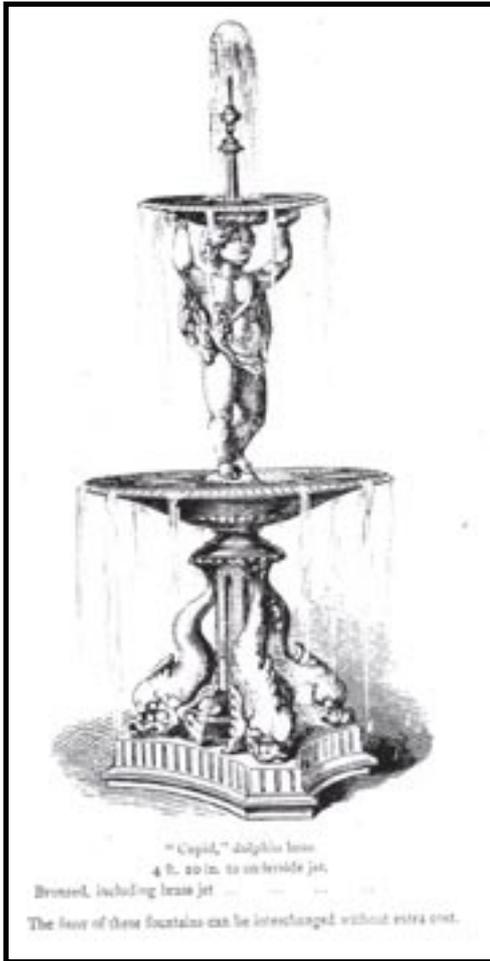
Above: The original centrepiece from the Coalbrookdale Foundry catalogue.

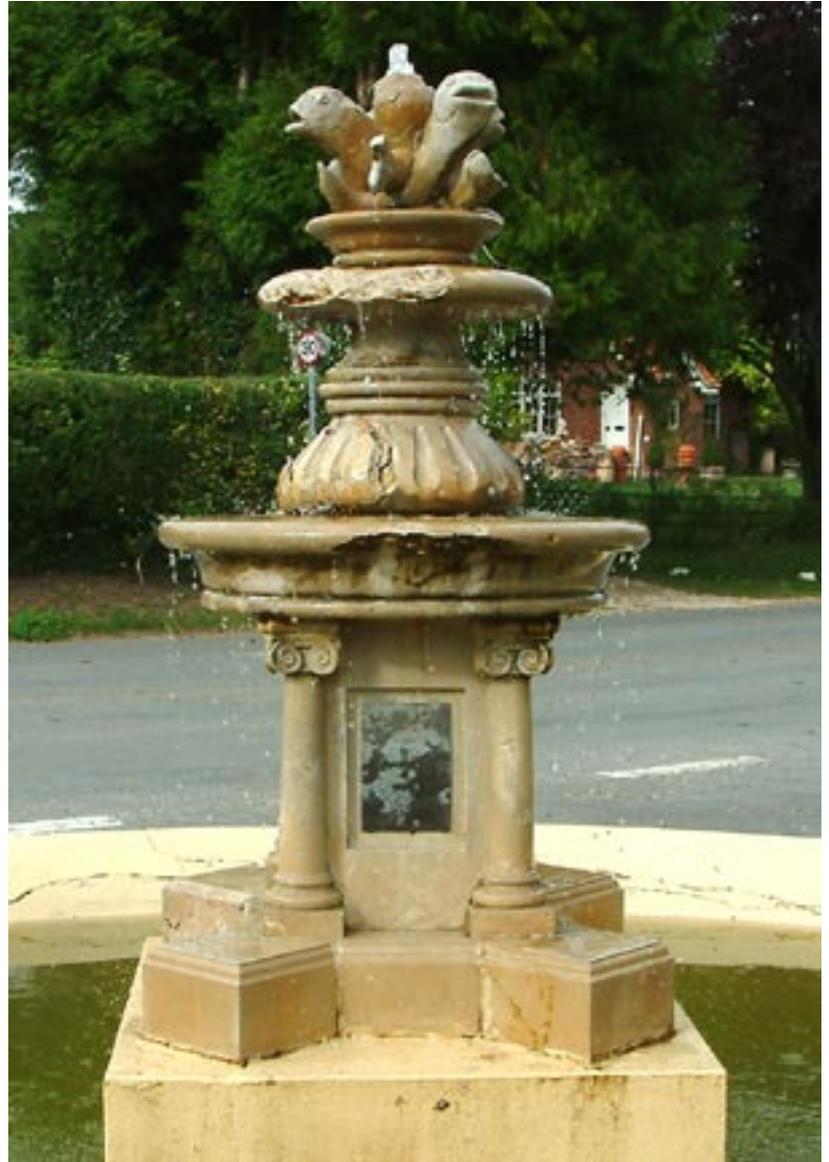
Below: Frost damage is clearly seen on the top fish, the 'mushroom' below, the 'cottage loaf' and the table.

The supporting pillars with their panels are in good condition. Some years back, the corner stones had to be replaced and now these too are starting now to decay.

Sadly the fountain is looking a bit forlorn despite cleanings, repairs and a coat of paint every few years. The centre piece has suffered the weather of many winters, particularly a few years ago when there was a long succession of night frosts followed by sunny days, an ideal recipe for freeze-thaw action that is so destructive to wet stonework. The surround sounds very hollow when hit and there are many cracks in it though these are not structural. Some of the rendering has come away in places.

A working party has been formed to consider the fountain condition and propose possible actions for the future. Initial quotations have been obtained and the view of the village was sought at the last Annual Parish Meeting in May. Residents expressed a general desire that the centre piece should be replaced with a simple cast-iron bowl and the surround repaired and rendered in the original shape.

A likely way ahead would therefore be to rebuild the surround and have it re-rendered. In the centre the plinth might be lowered and a cast-iron bowl chosen as a replacement for the existing stonework. A new pumping and filtration system would complete the restoration. Draining the fountain is quite a problem, so re-positioning the drain would be beneficial.

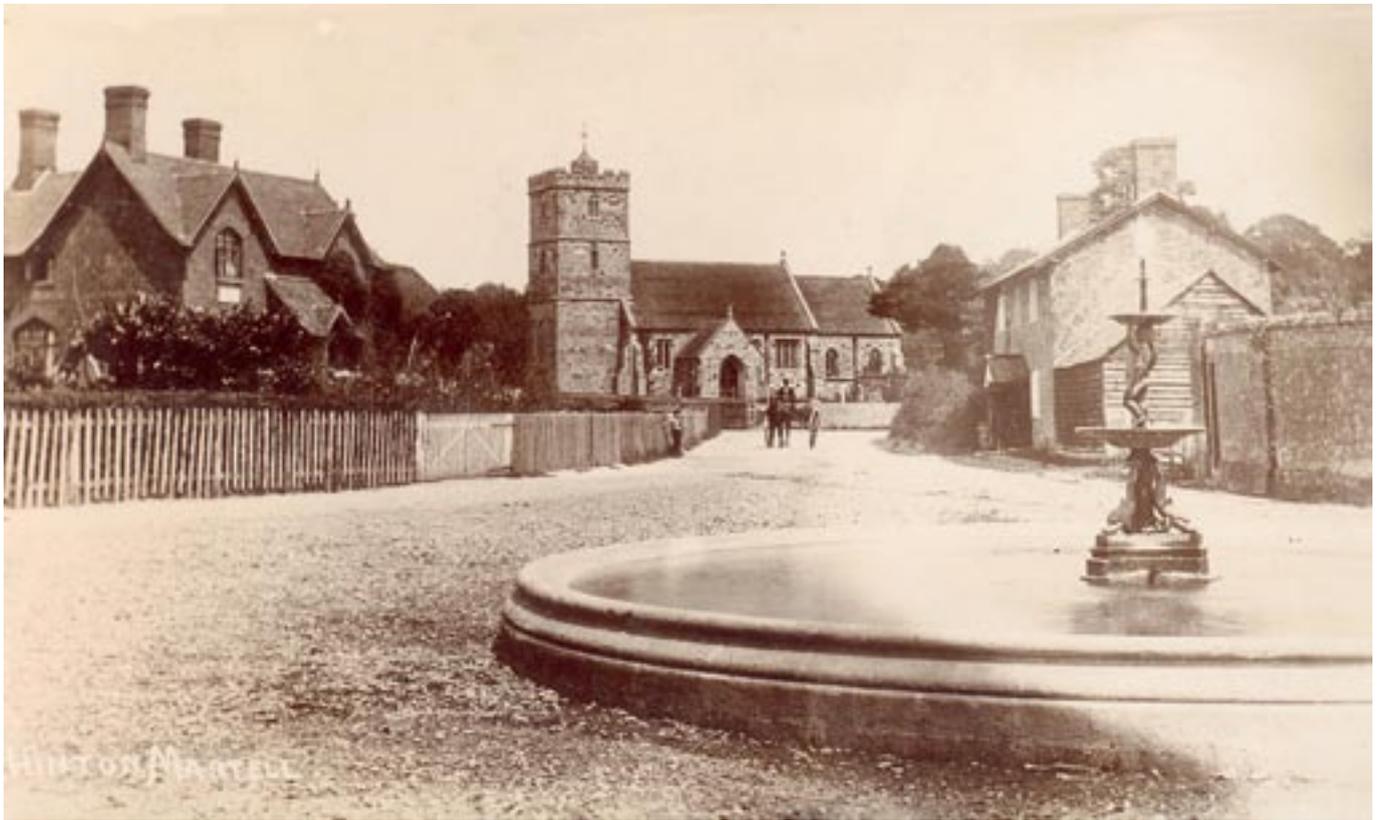
Hinton Martell fountain circa 1910. The iron centrepiece can be clearly seen along with the pleasing lines of the moulded rendering of the surround.

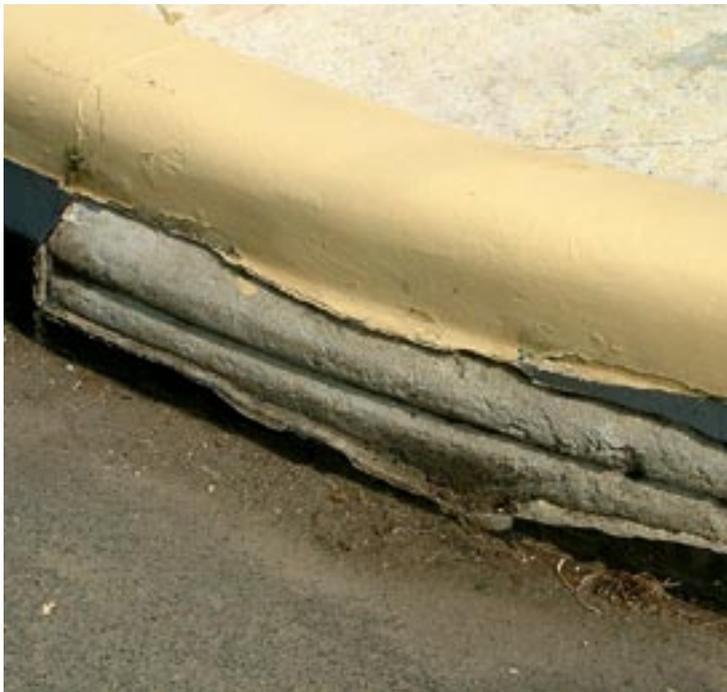
An exploratory cut made into the surround of the fountain, revealed what is probably the original foundation of soft red brick rendered with a hard grey cement. The later rendering of 1965 has been applied over the original hiding the pleasing lines.

Some of the original rendering visible underneath the rendering applied in 1965.

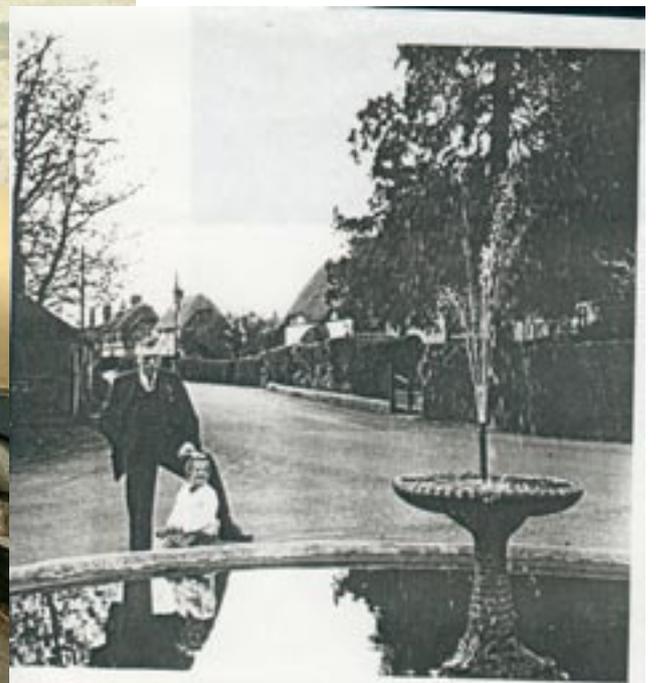
Possibly the first iron centrepiece was removed for scrap to aid the First World War effort. A replacement iron bowl appears in photos and was removed to make way for the 1965 renovation.

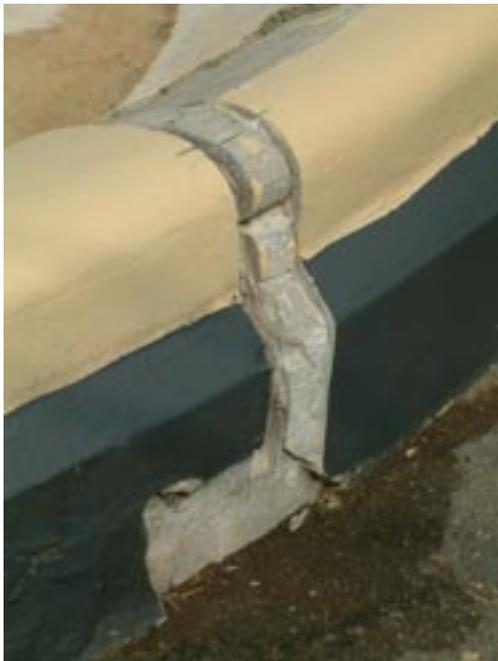
A cut into the surround revealed the original brickwork and rendering.
